## **APPENDIXES**

This Appendix contains prints of digital images depicting natural and cultural aspects of the project area on Kelleys Island, Ohio. The Appendix is subdivided into 4 sections which comprise the following topics:

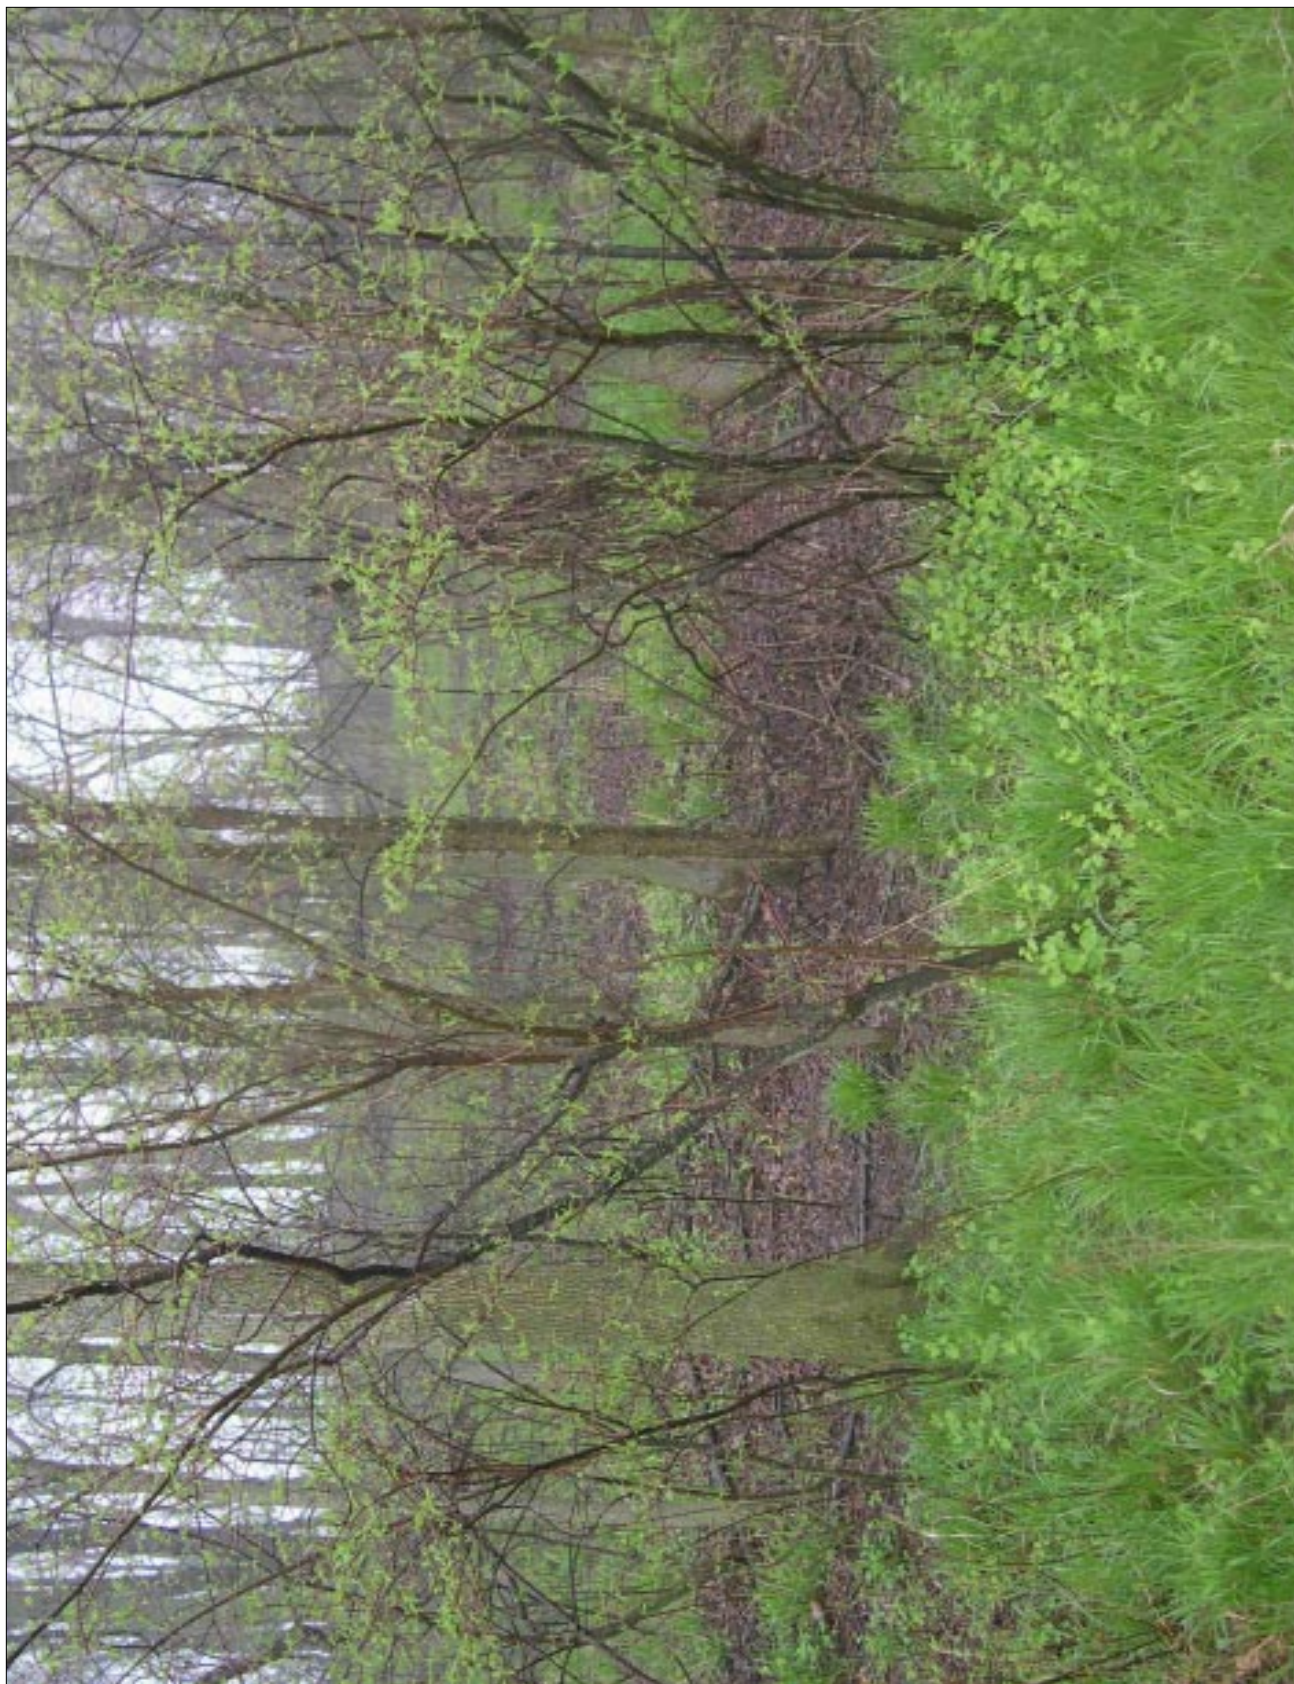
*Image WL-1. A suspected vernal pool wetland along the eastern boundary of the Predevelopment, Ltd. tract (April 30, 2004).*

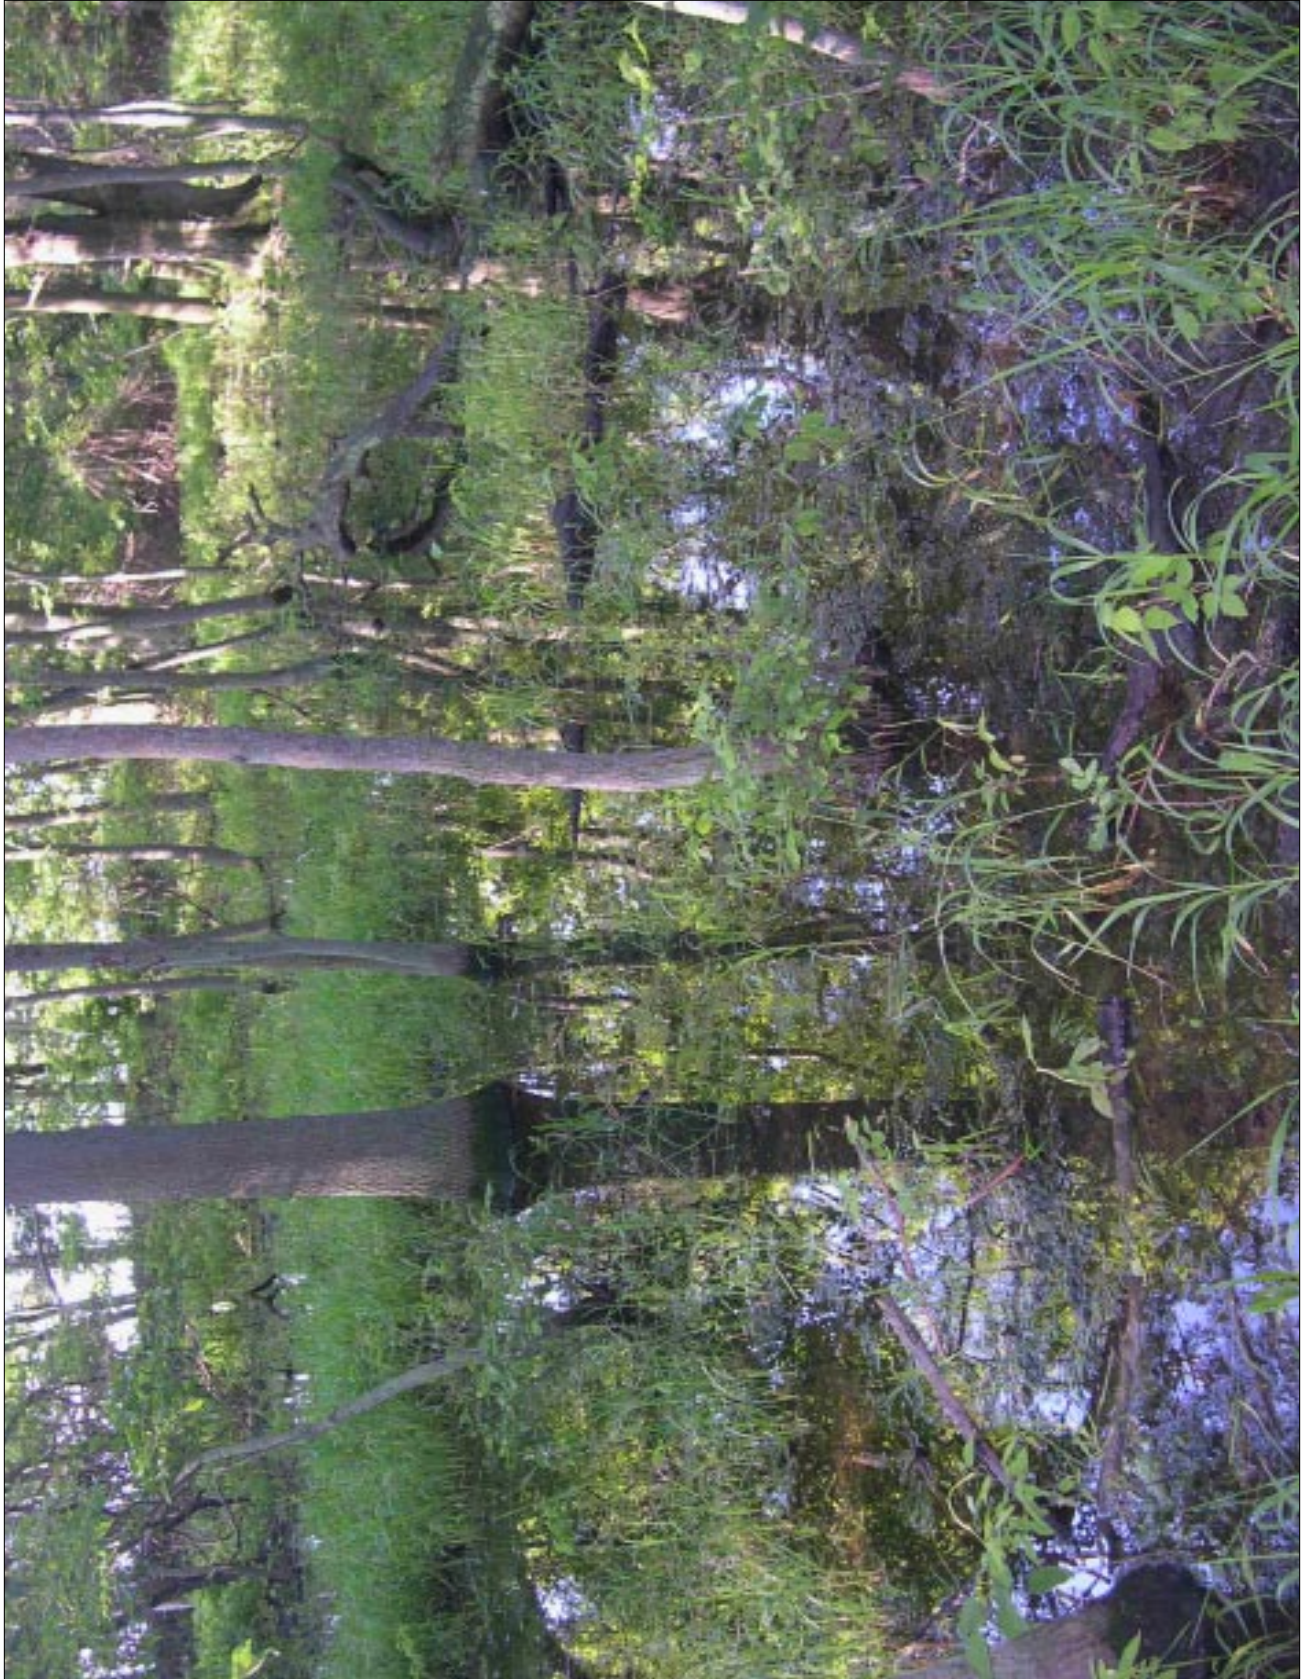
*Image WL-2. Vernal pool wetland in same area as WL-1 following spring rains in May (June 3, 2004).*

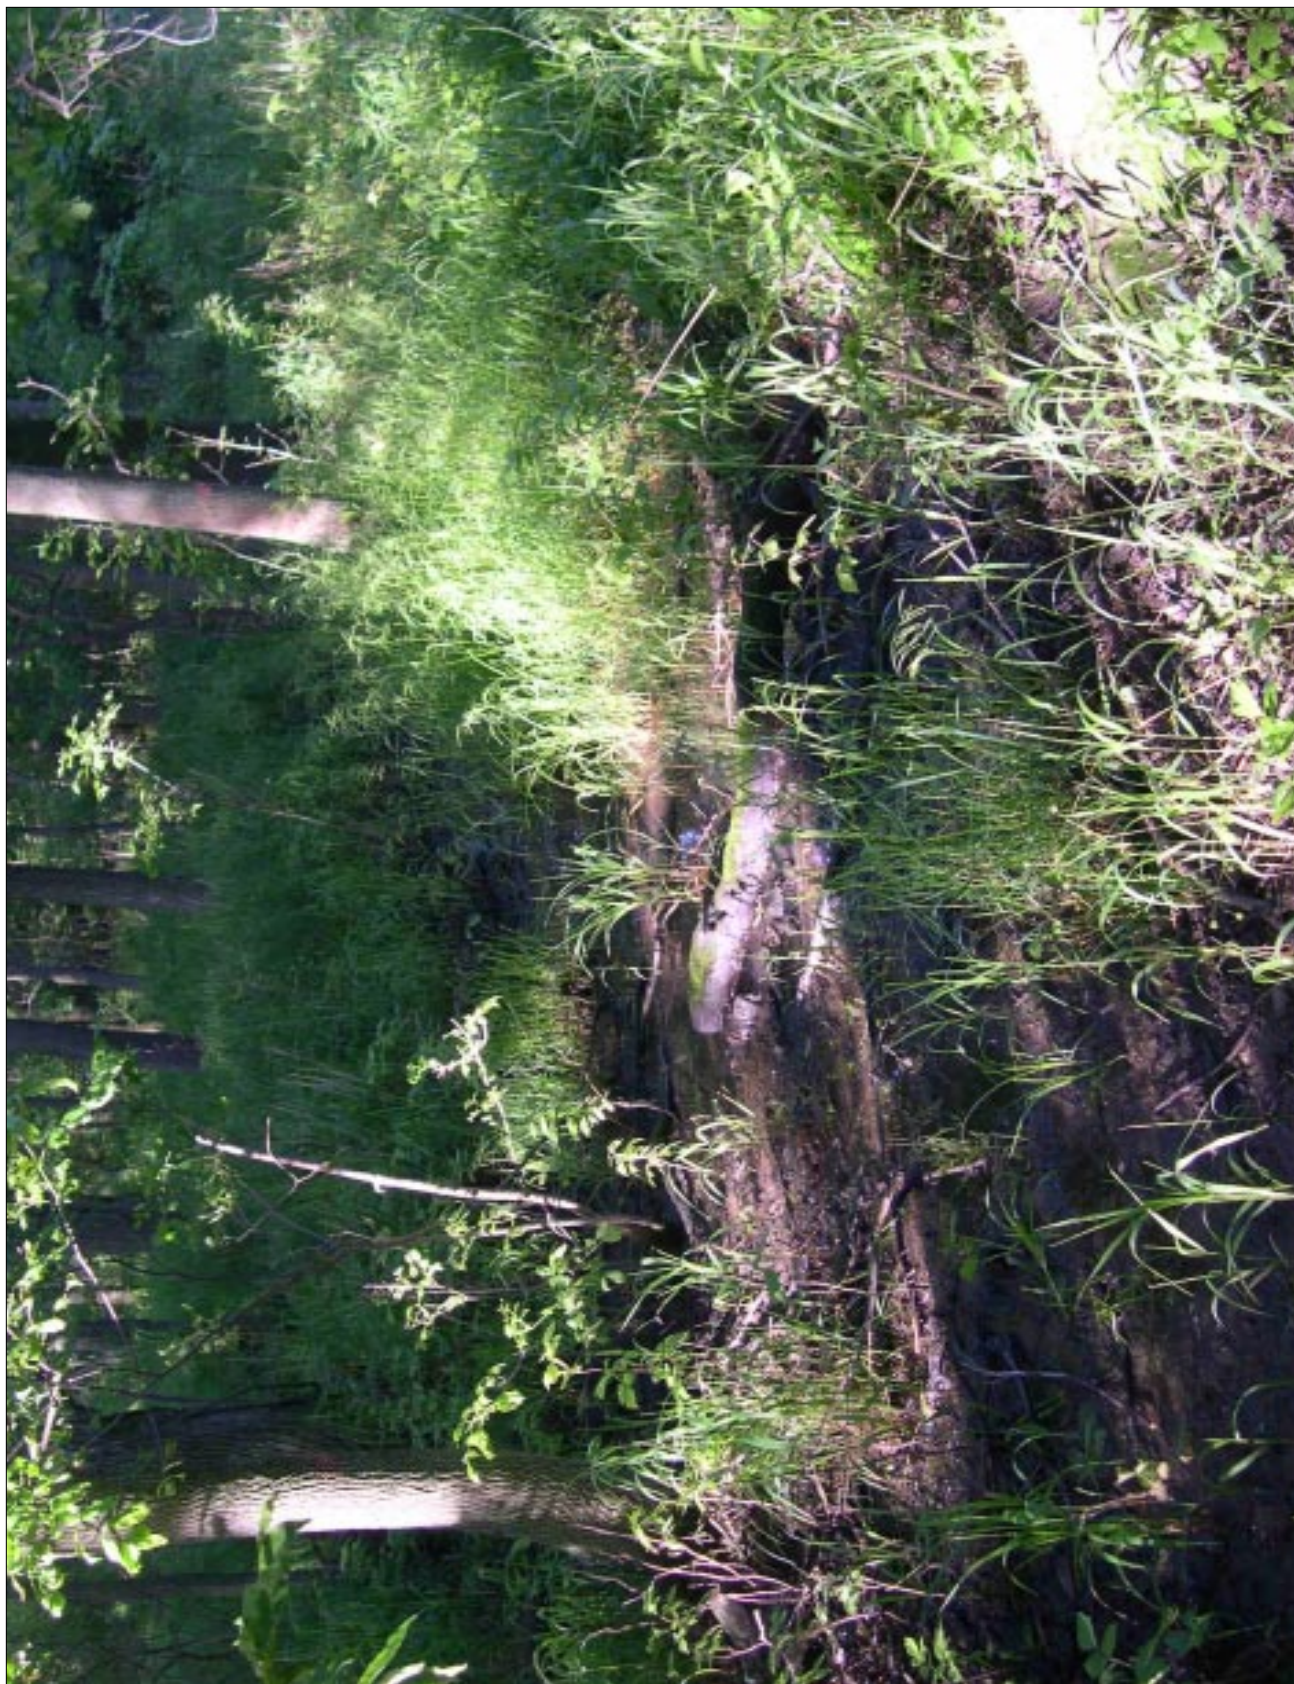
*Image WL-3. Vernal pool wetland in forested area east of Long Point Lane (June 3, 2004).*

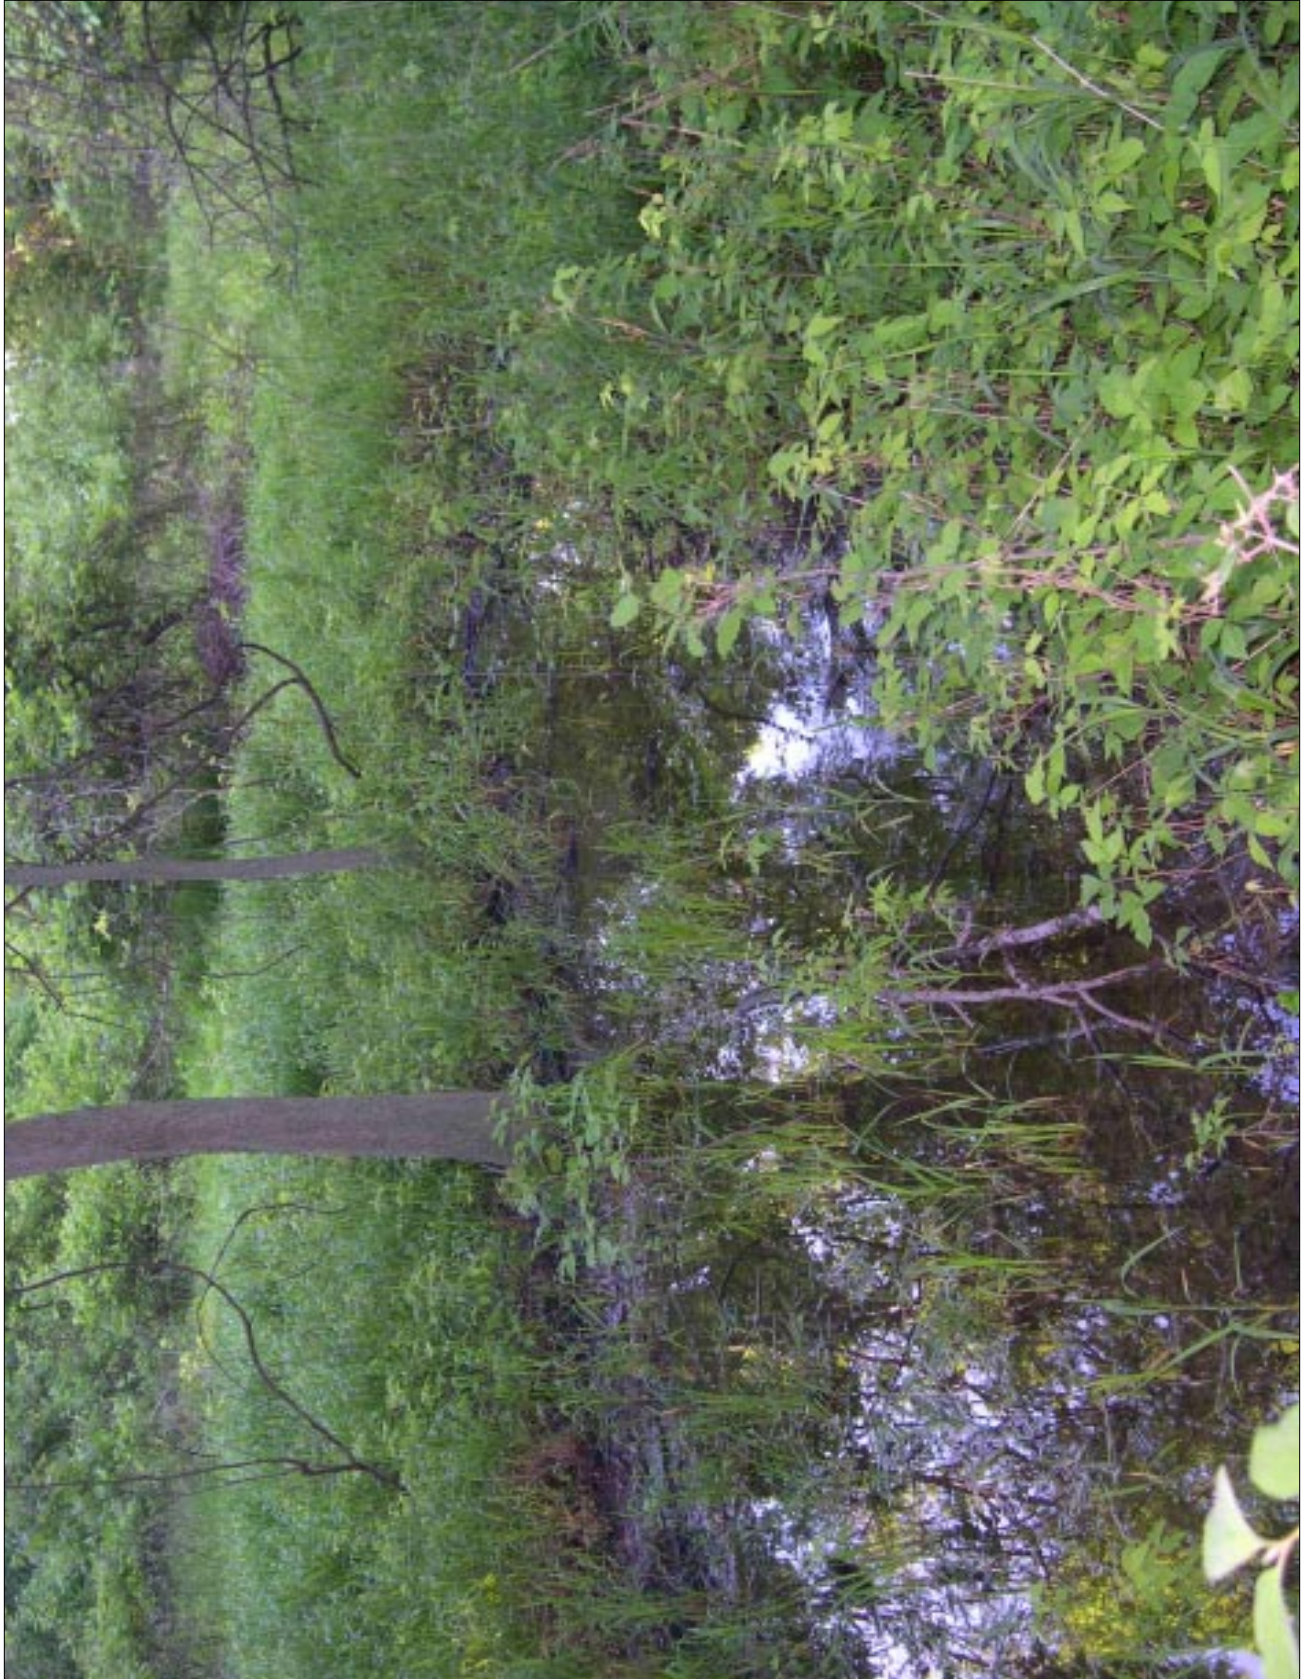
*Image WL-4. Vernal pool wetland, showing growth of sedges in standing water (June 3, 2004).*

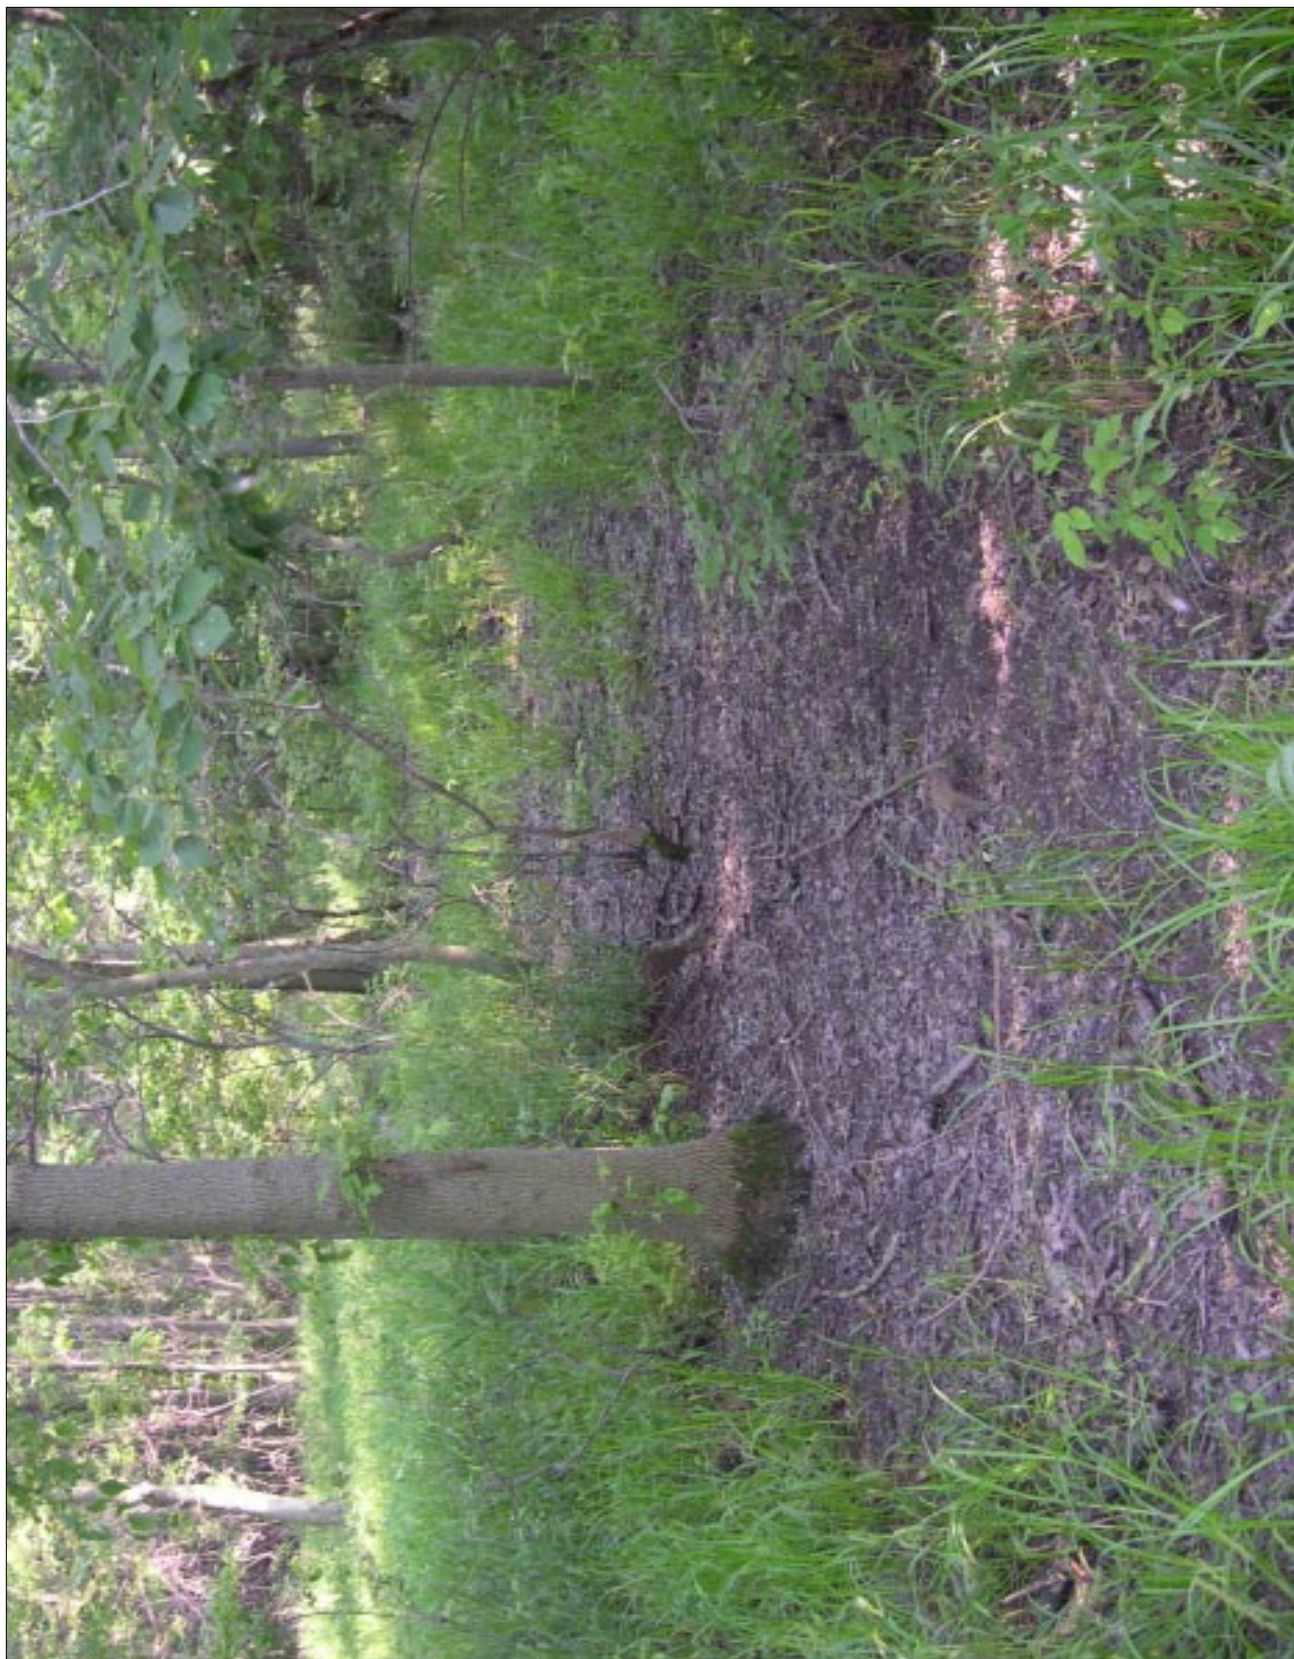
*Image WL-5. Vernal pool wetland in same area as WL-4, showing absence of standing water about one week after a rain. Sedge is Carex frankii (June 8, 2004).*

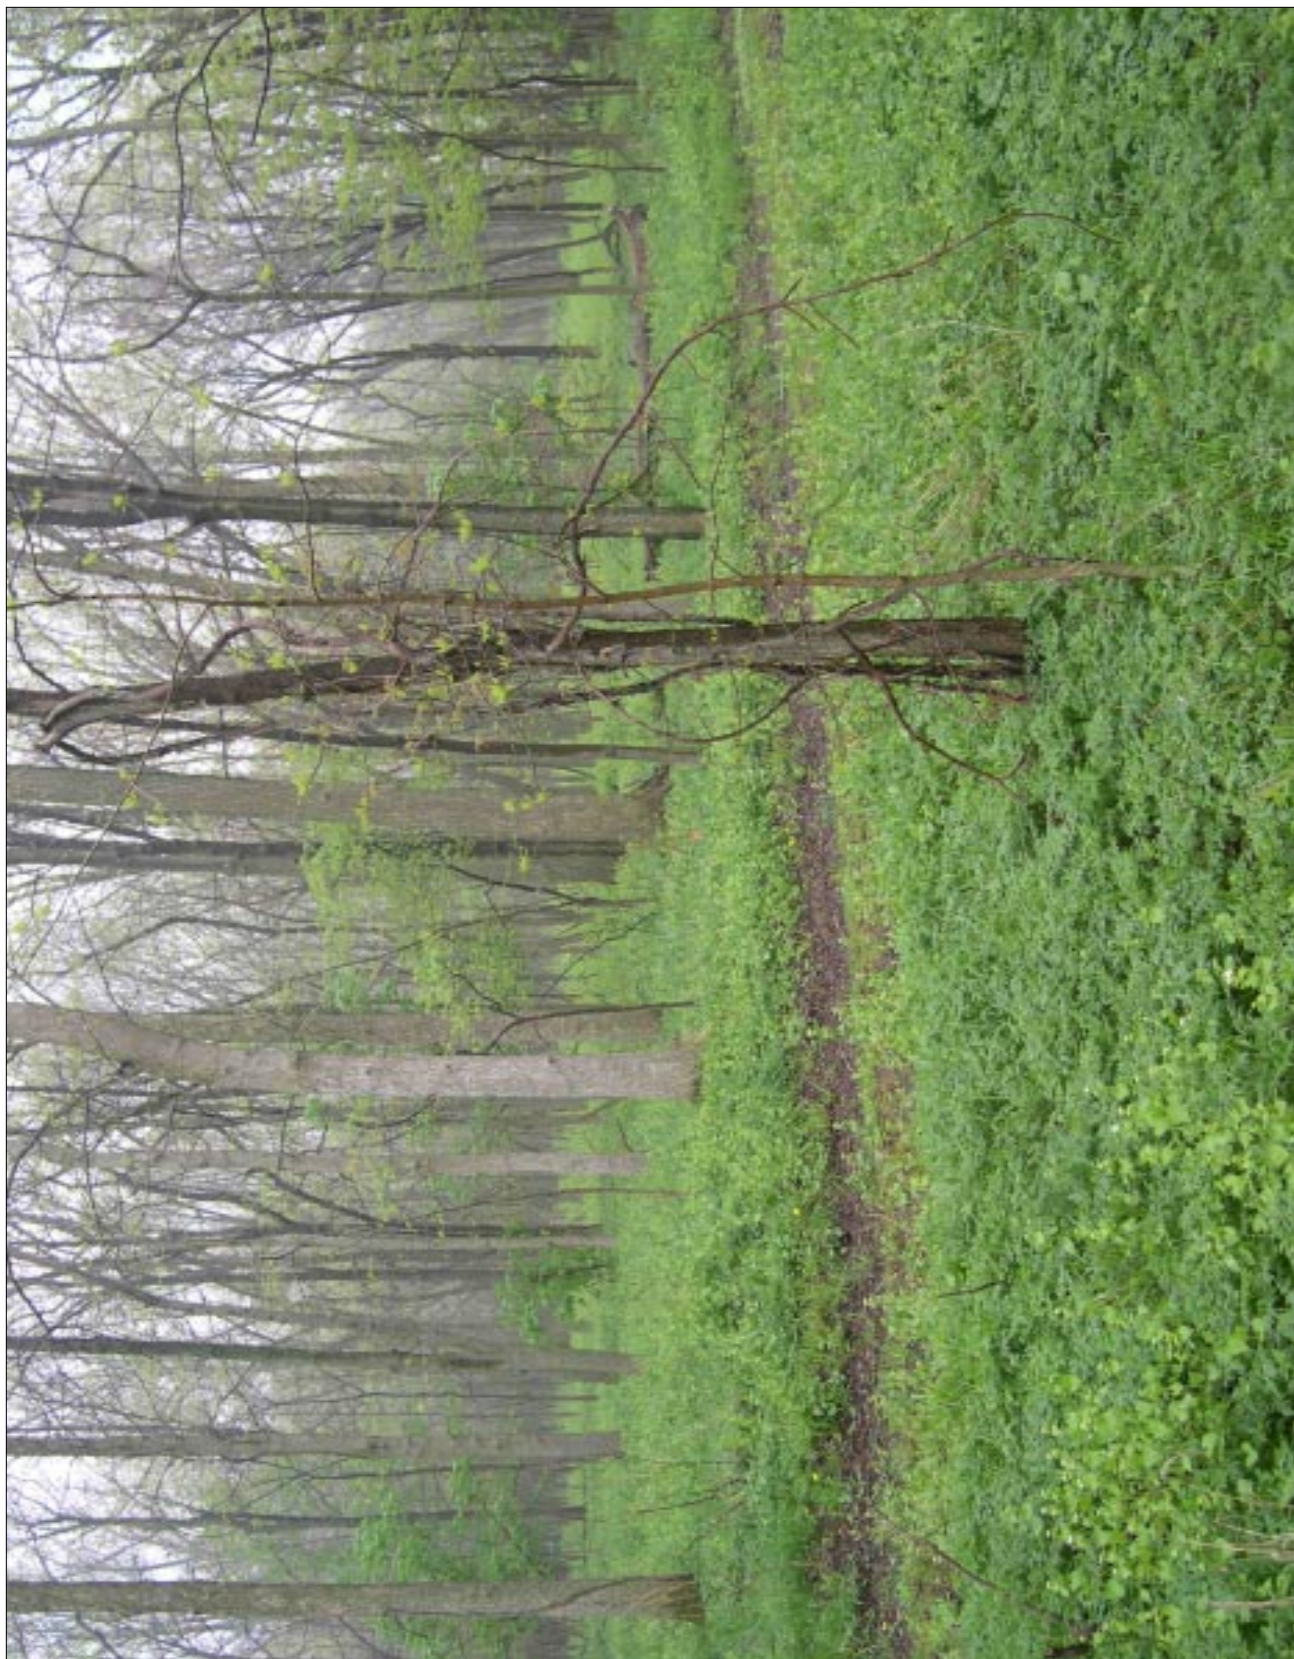
*Image BE-1. View from the northern end of the Building Envelope, showing the forest and dense ground cover (April 30, 2004).*

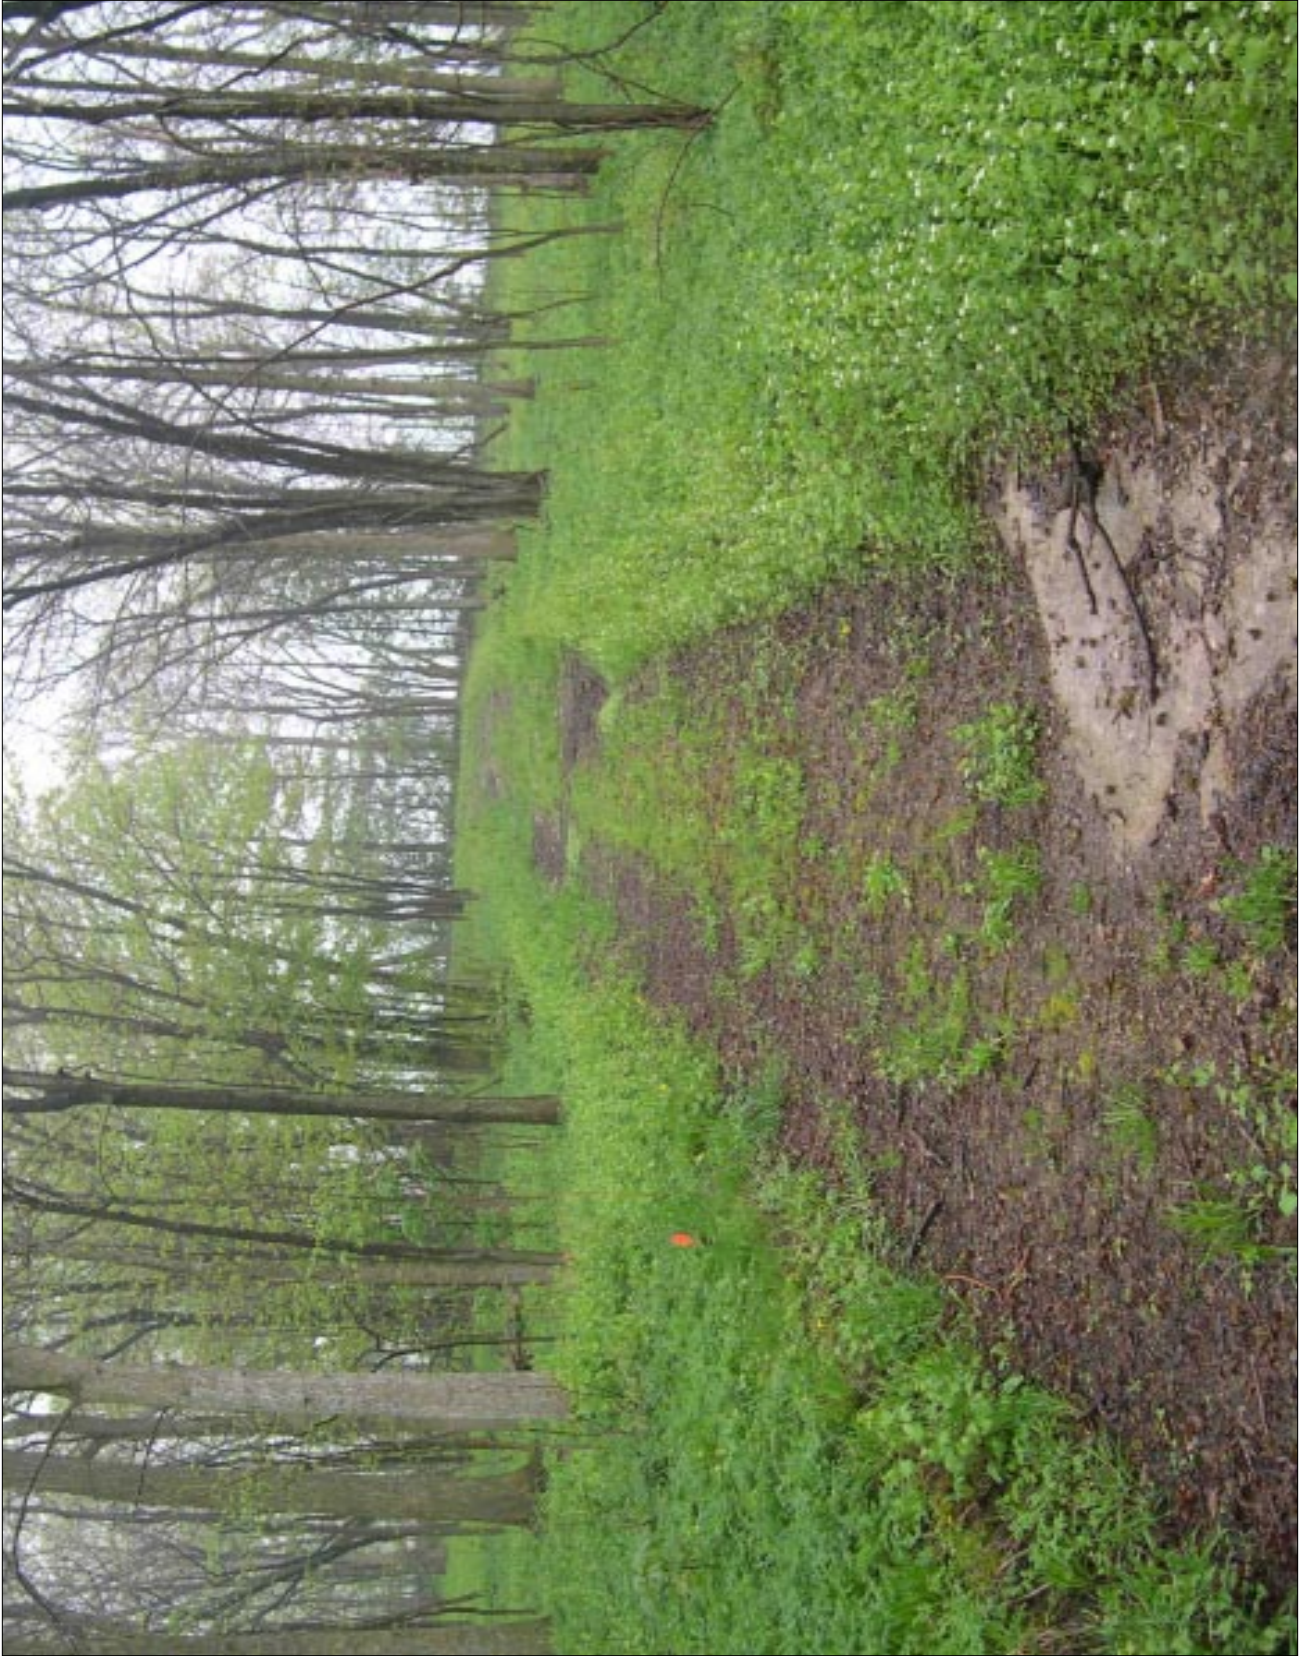
*Image BE-2. View of the abandoned Monagan Road which traverses the northern portion of the Building Envelope, showing the exposed bedrock (Columbus Limestone) in the road bed (April 30, 2004).*

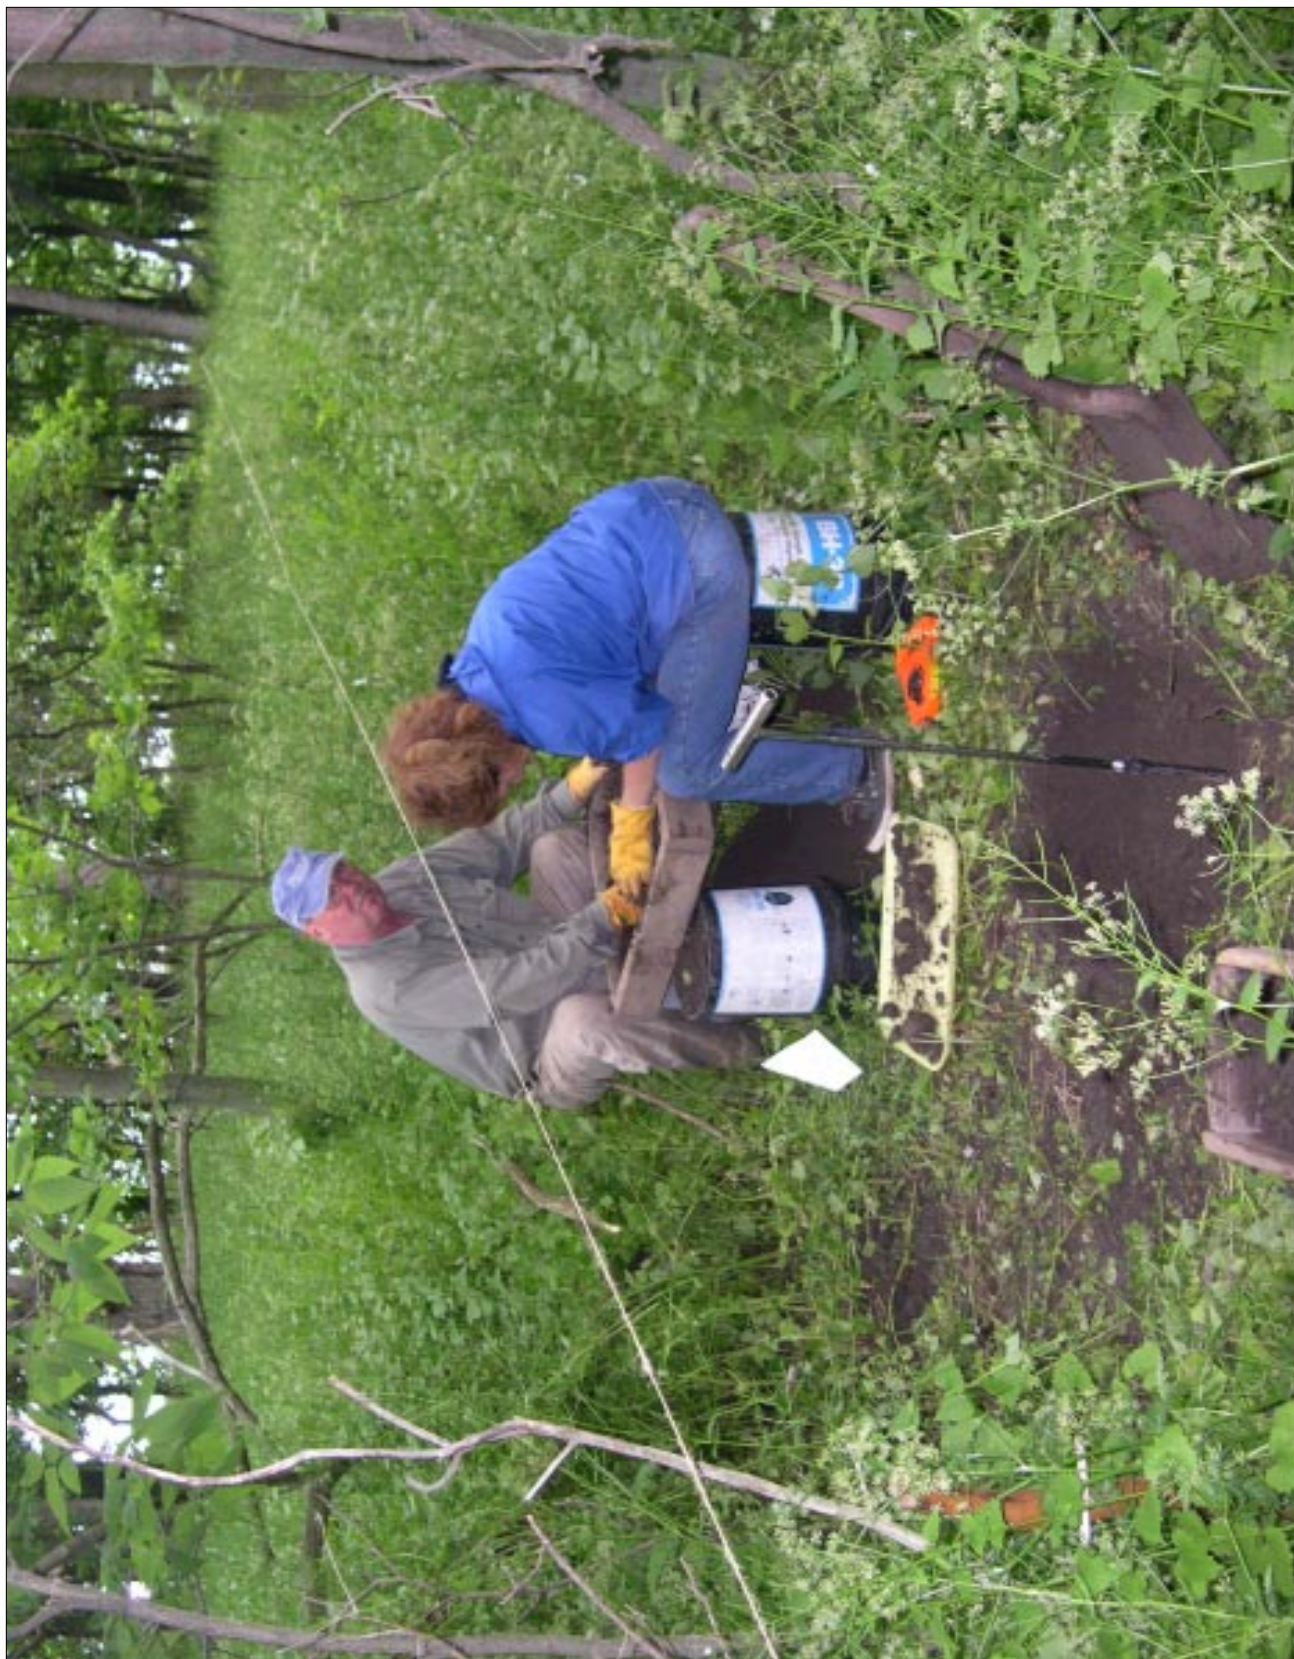
*Image BE-3. Shovel test pit at station C-2 in the Building Envelope, showing the dark grayish brown Milton soil; 17 pieces of chert were recovered from this pit (May 27, 2004).*

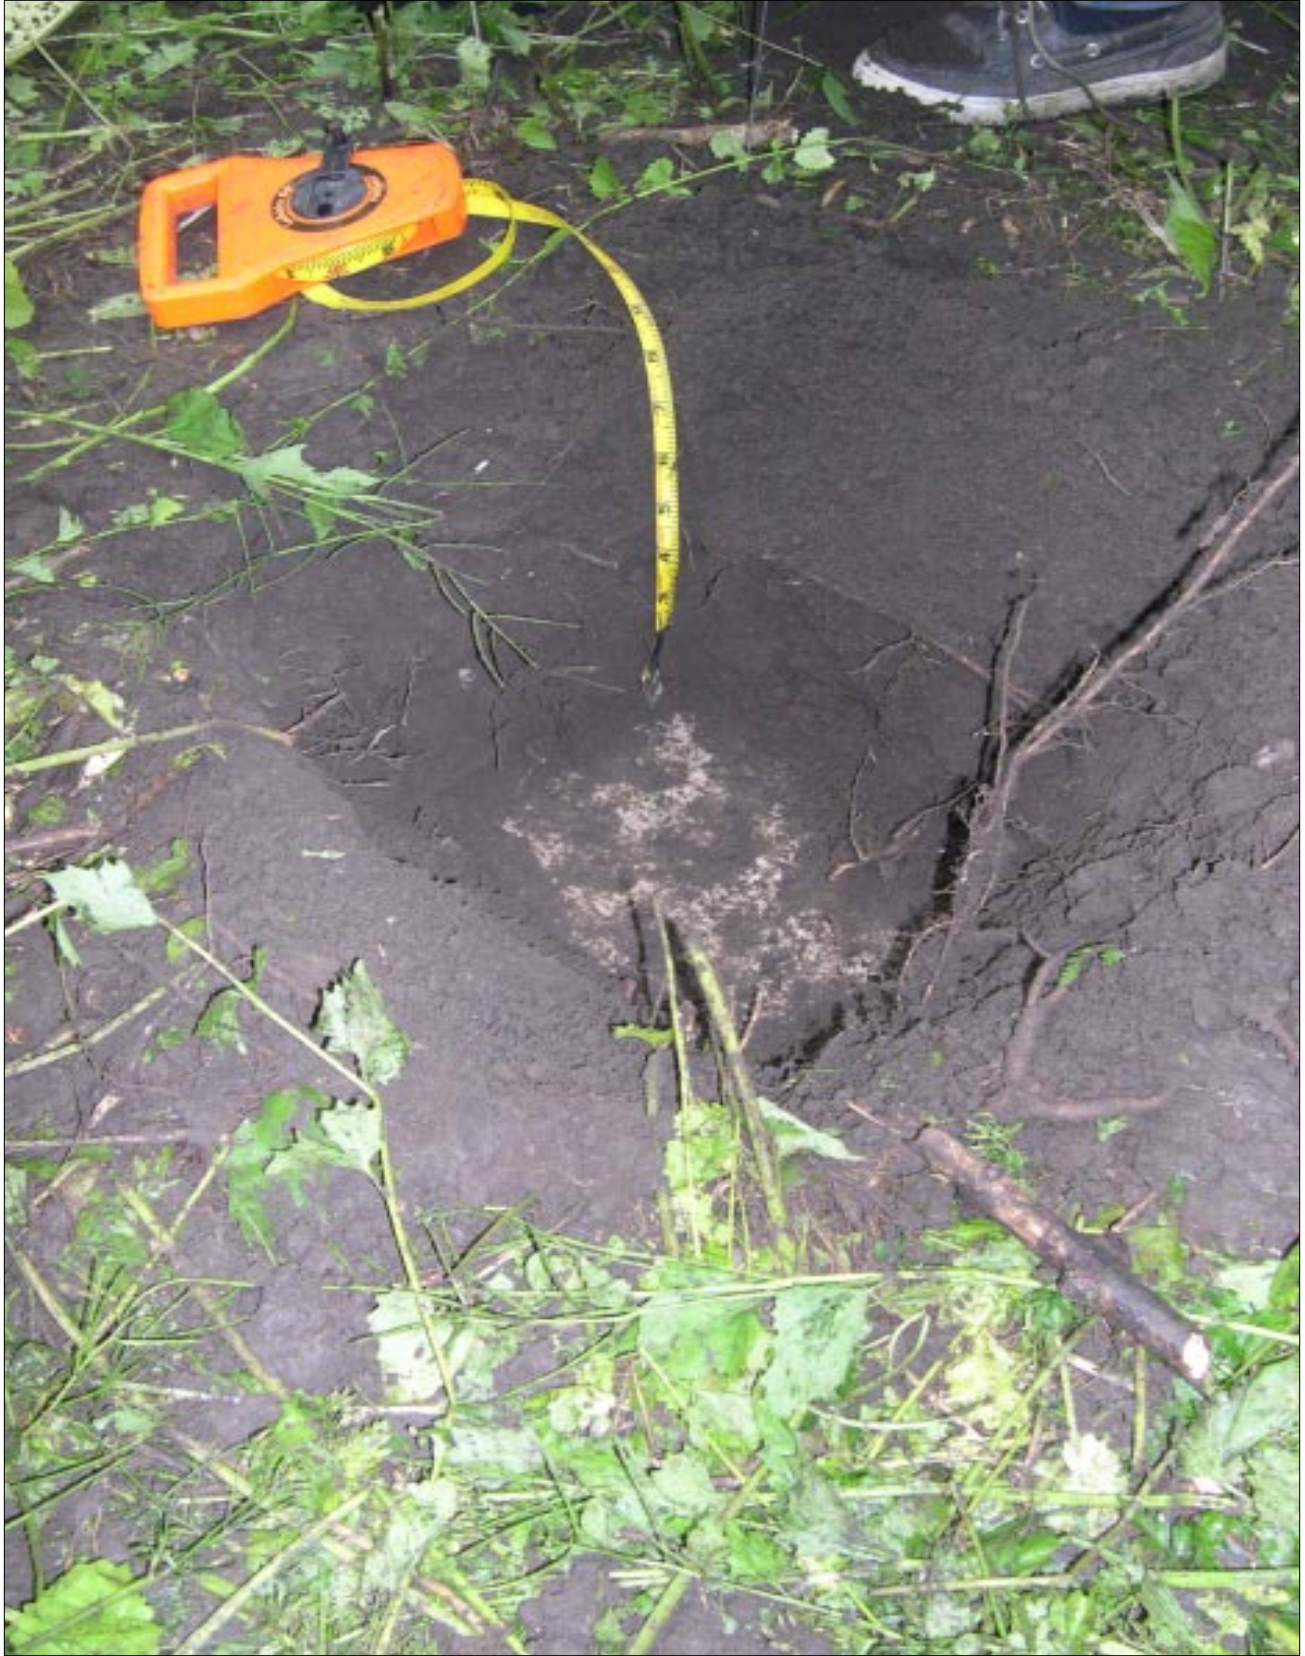
*Image BE-4. Shovel test pit at station E-2 in the Building Envelope, showing bedrock surface at depth of 0.8 ft below dark grayish brown Castalia soil; 4 pieces of chert debitage were recovered (May 27, 2004).*

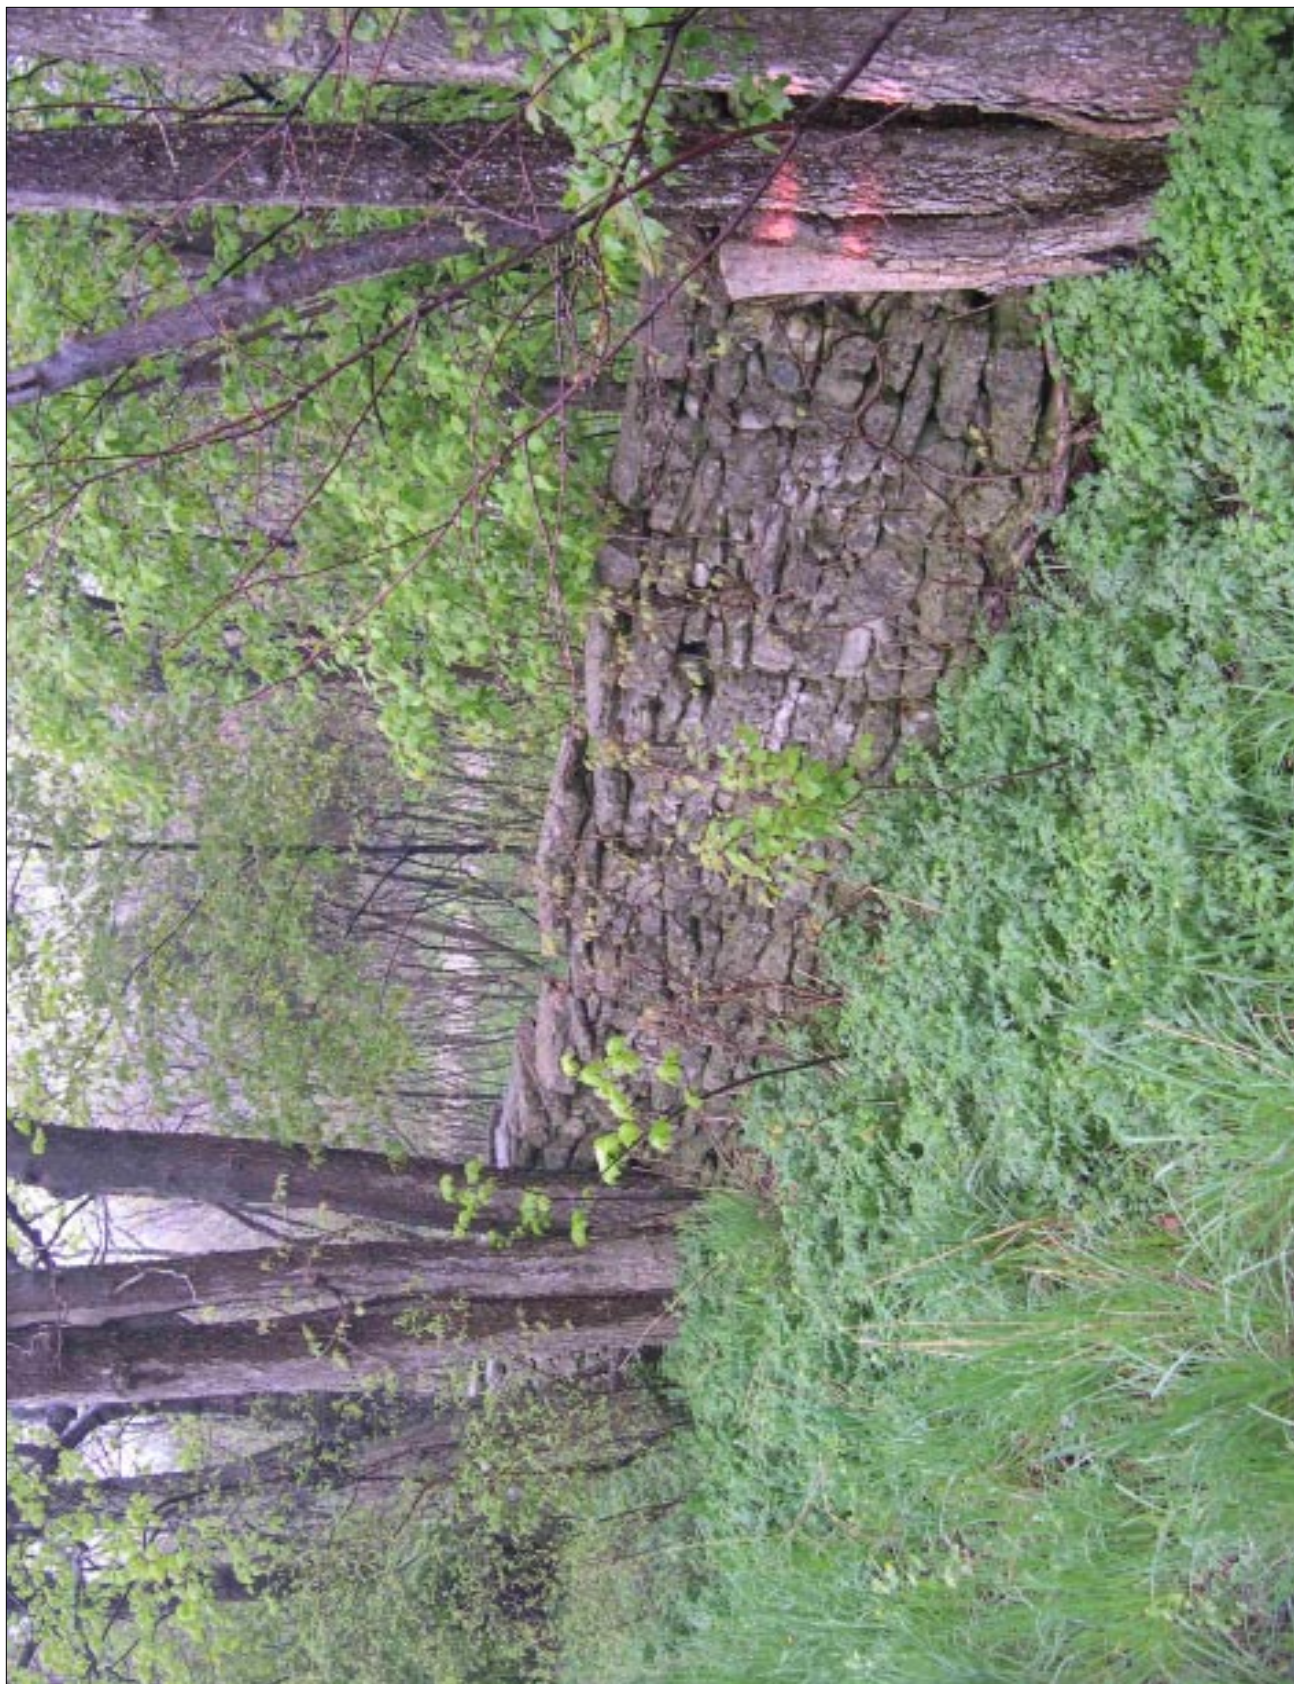
*Image LW-1. Lincoln Stone Wall (ca. 1865) near the southwestern end of the Predevelopment. Ltd. tract; height of wall 1 m (April 30, 2004).*
